BaySys 2017 Mooring Program Cruise Report

Research Vessel: Canadian Coast Guard Ship (CCGS) Henry Larsen

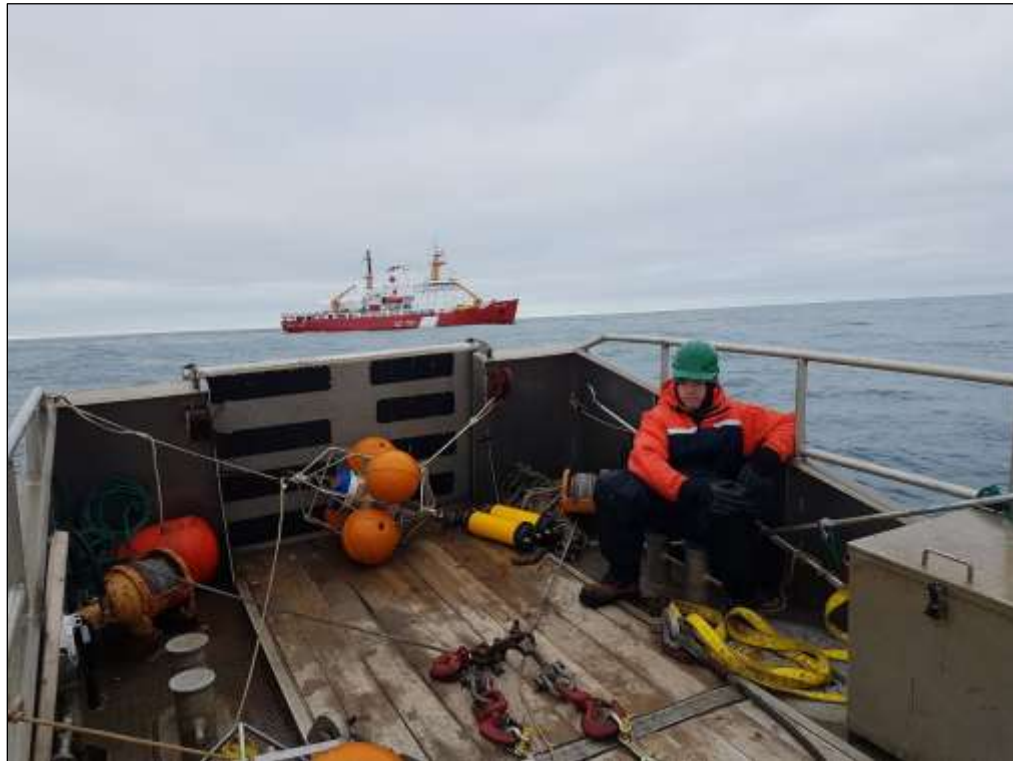
Figure 2. Onboard the barge with a recovered mooring.

Despite the fact that the late autumn is usually very windy in the Hudson Bay region, the last days of October 2017 were relatively calm with a relatively light wind speed. Such a good weather allowed us using the ship's barge for NE02 and NE03 mooring recoveries (Figure 2). The barge was equipped with two small winches that were used to pull the mooring line and instruments onboard. Taking into account the relatively short length of all moorings, the recovery of NE03 and NE02 took approximately 30-40 minutes after the mooring's release. The heavy Trawl Resistant Bottom Mount (TRBM) at NE02 was the only element which could not be lifted on the barge's deck and it was drawn to the ship for lifting with a crane (Figure 3). For AN01 mooring, the zodiac boat was used to assist the recovery that was made with a crane from the ship's foredeck.

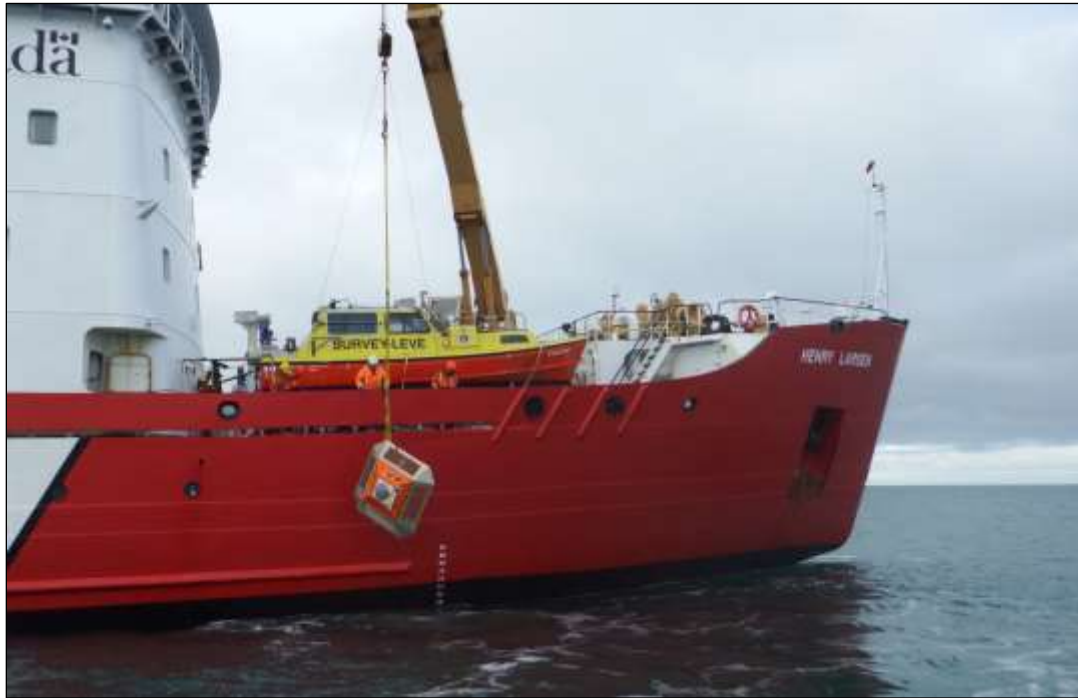
Figure 3. Lifting the TRBM (NE02) onboard Henry Larsen.

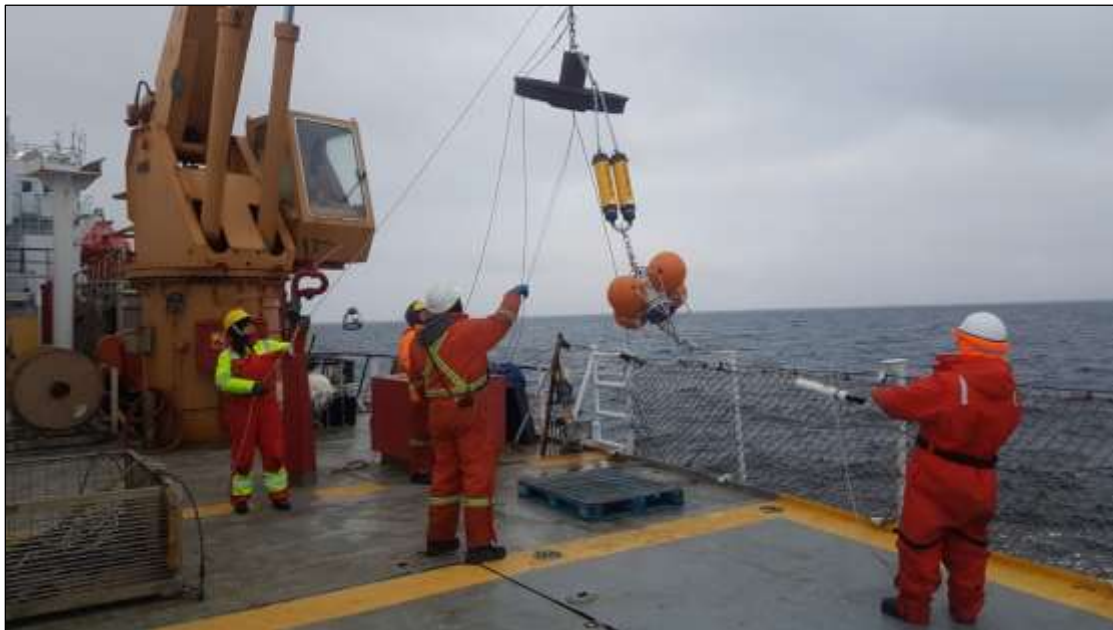
Figure 6. Mooring deployment from the helicopter deck

The recovered moorings were re-deployed from the helicopter deck by using the crane at the starboard side of the ship (Figure 6). The relatively short length of all moorings allowed deploying them “anchor last” (Figure 7). Although all acoustic releases were found functioning well, we kept using two acoustic releases at each mooring to increase the mooring survivability in a case of one of releases failure. The moorings were deployed in the same positions (or in a close vicinity) as in 2016.

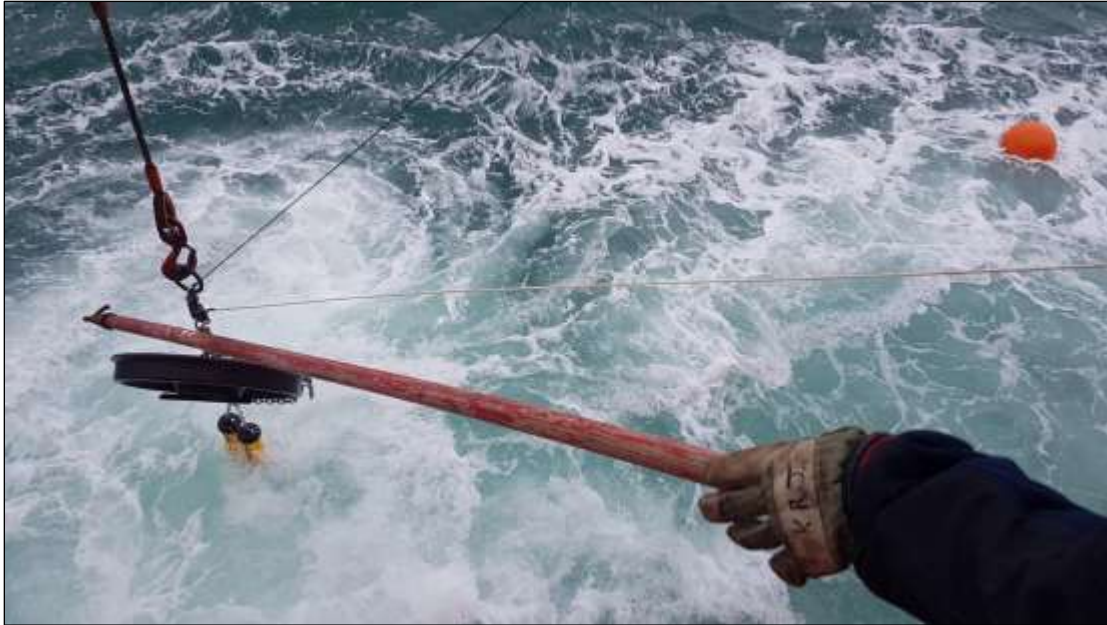
Figure 7. Approaching to the release of anchor

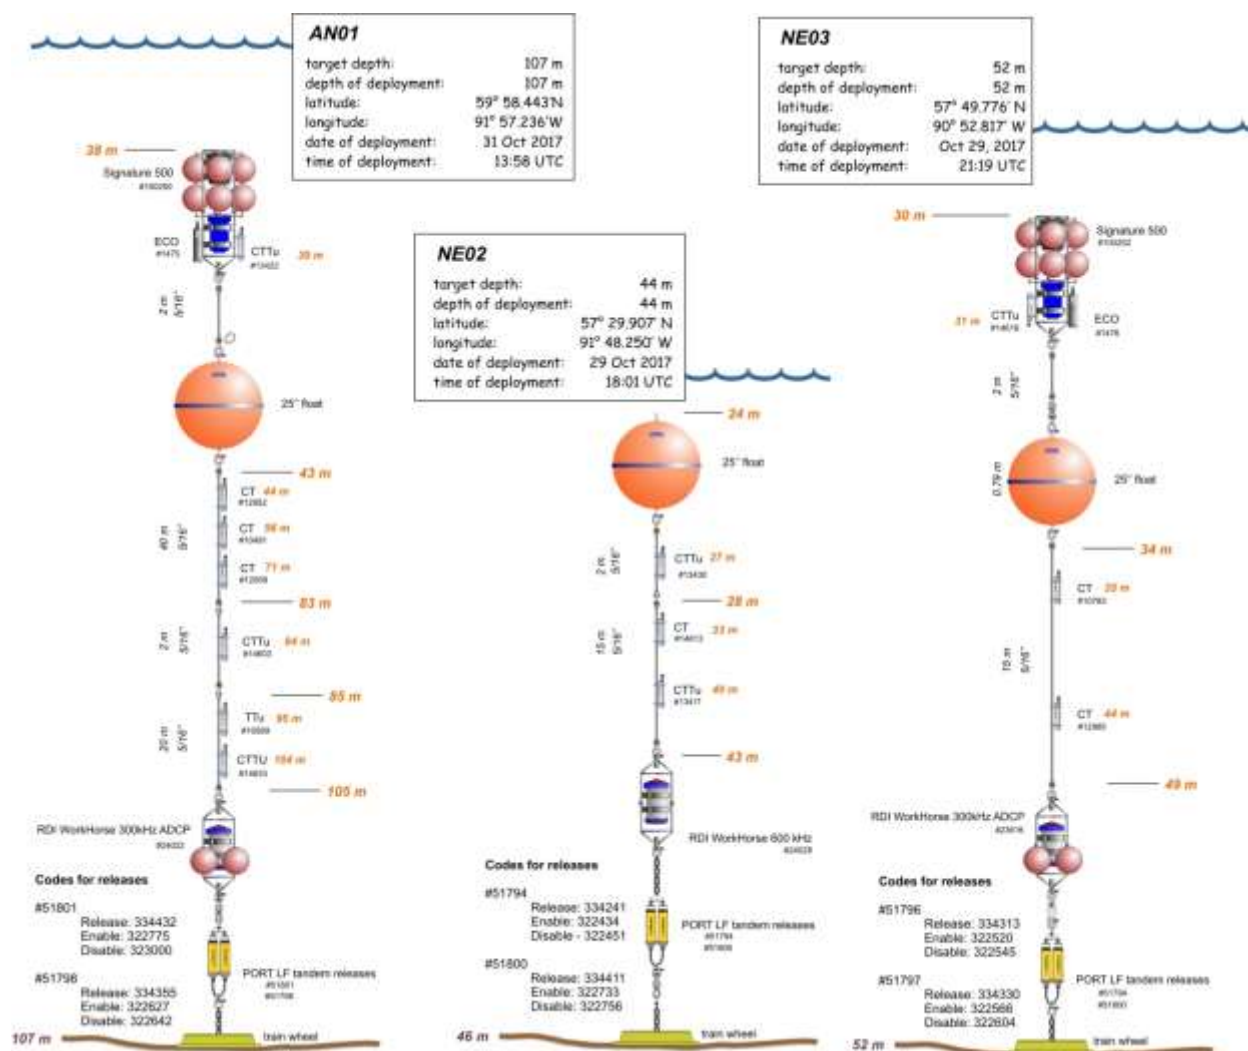
Figure 8. The new configuration of AN01, NE02 and NE03 moorings

We kept the same configurations of moored instruments at all three moorings with the minor changes related to the removal of sediment traps and buoyant tubes near the surface. The TRBM at NE02 was also replaced with an in-line not-magnetic frame for carrying the upward-looking ADCP near the bottom. All mooring components were programmed for a one-year deployment with the suggested recovery in early summer 2018 from CCGS *Amundsen*. The mooring configurations, time of deployments, coordinates and the codes for acoustic releases are presented in Figure 8.

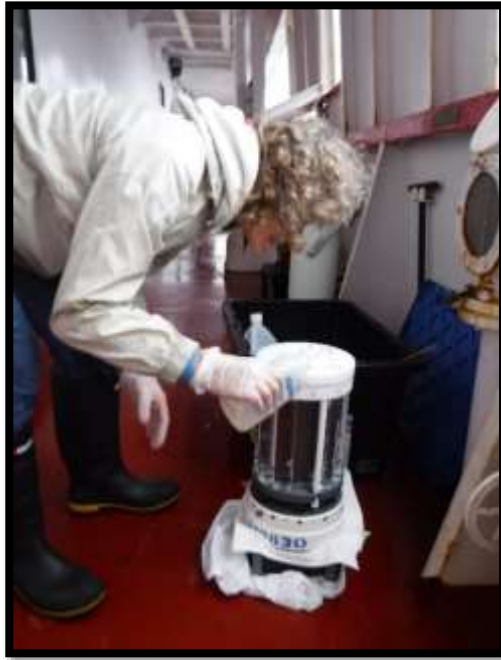
Figure 9: The rosette of the sediment traps being filled with density gradient solution before deployment.

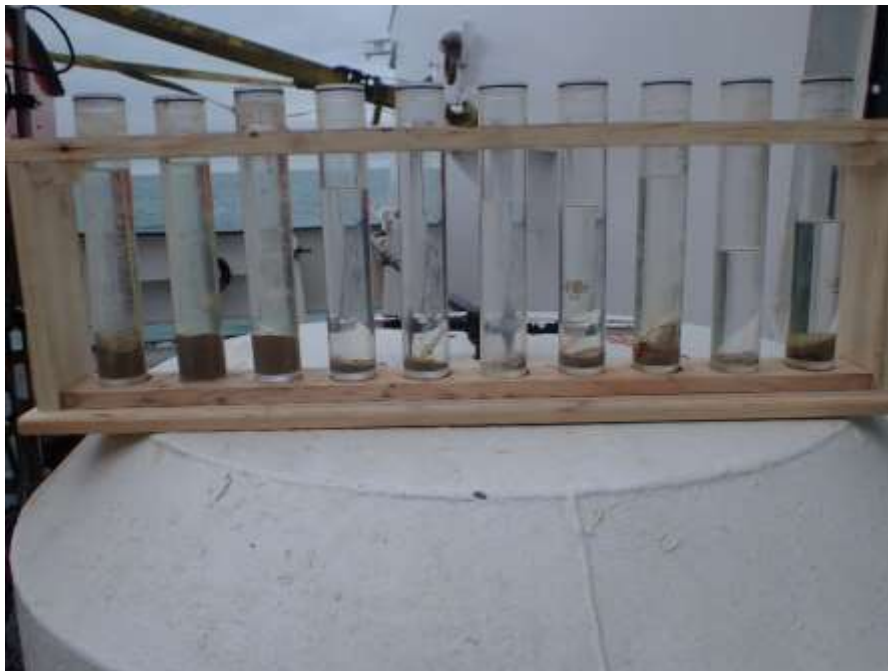
Figure 10: The vials from the sediment traps in the vial rack.

The Sediment traps on moorings AN01, NE02 and NE03 were successfully recovered and were not redeployed. Mooring JB02 was not recovered during this operation. Once on board the traps were dismantled, first removing the PVC tube that houses an asymmetrical funnel, the stabilising fins and then the sample vials from the rosette (Figure 9). The samples were placed into a vial rack numbered from 1 to 10 (Figure 10). The vials were then emptied into labeled amber jars which were then packed and stored in cooler on the deck. The sediment traps were then reassembled, cleaned with freshwater and then packed in their respective boxes for transport. The samples collected have been placed in cold storage (-4°C) and are yet to be analyzed.

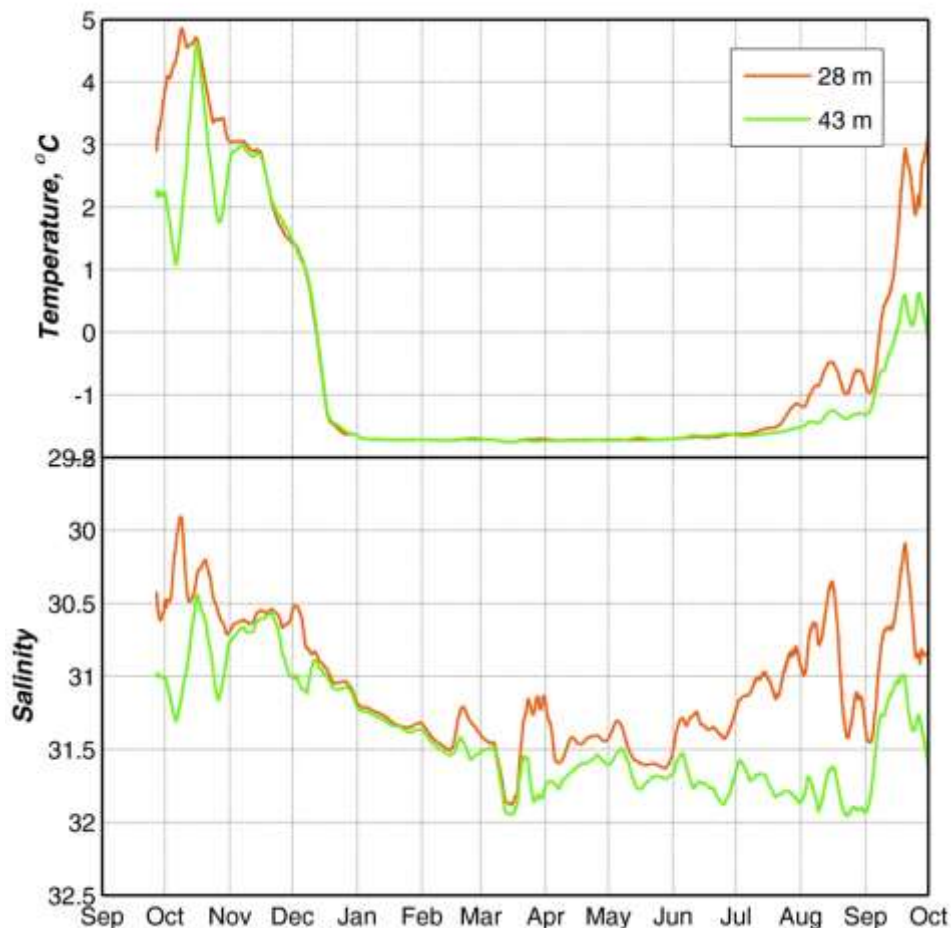
Figure 11. The one-year evolution of vertical thermohaline structure at NE03 mooring

The CT sensors deployed at different depths captured the seasonal changes in vertical thermohaline structure at all three positions. These changes correspond to the impact of different processes such as: the vertical mixing and redistribution of heat from the surface to the deeper layers in autumn; cooling of water column and the following salinity increase due to the

sea ice growth in winter; the freshening and warming associated with sea ice melting/river runoff and solar heating in summer (Figure 11).

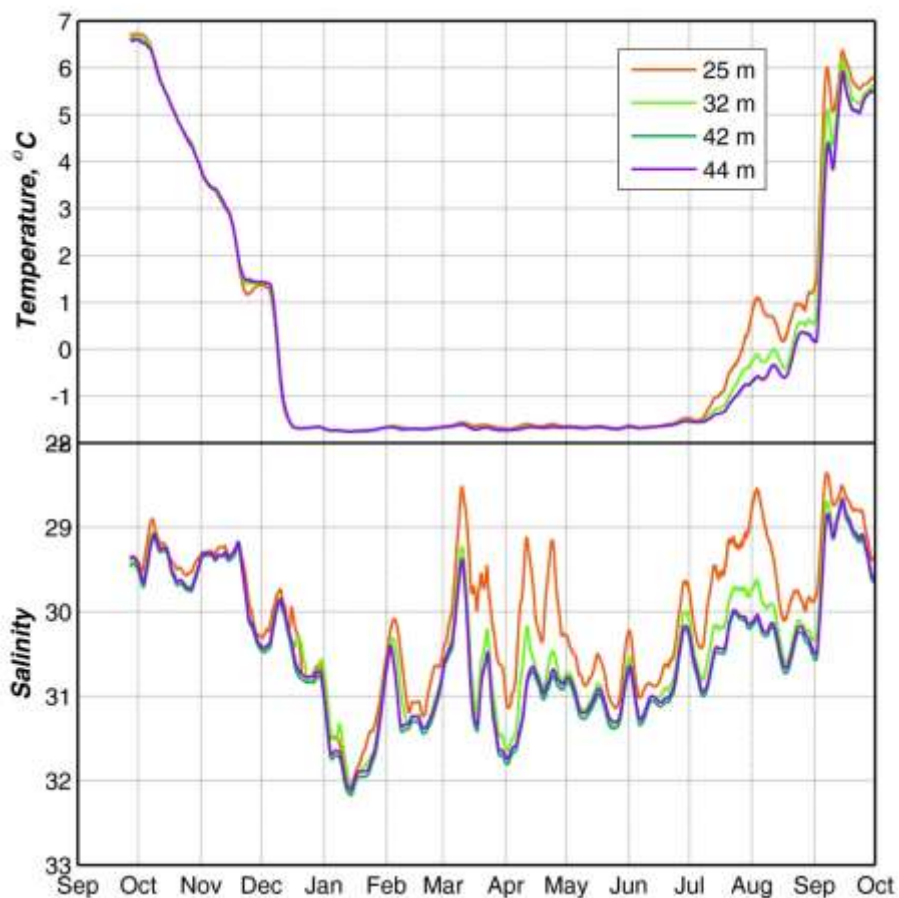
Figure 12. The one-year evolution of vertical thermohaline structure at NE02 mooring

The effect of atmospheric circulation on vertical thermohaline structure and freshwater content is clearly seen in CT data at NE02. The altering wind forcing led to the shift of the frontal zone formed by fresher coastal water (diluted by rivers' discharge) and saltier basin water. For instance, the considerable freshening observed at NE02 mooring on March 8 and September 3 was associated with low atmospheric pressure systems passing over the Hudson Bay. The storm winds resulted in on-shore water transport that blocked riverine waters near the shore and caused abrupt salinity decrease by 1.5-2.0 (Figure 12).

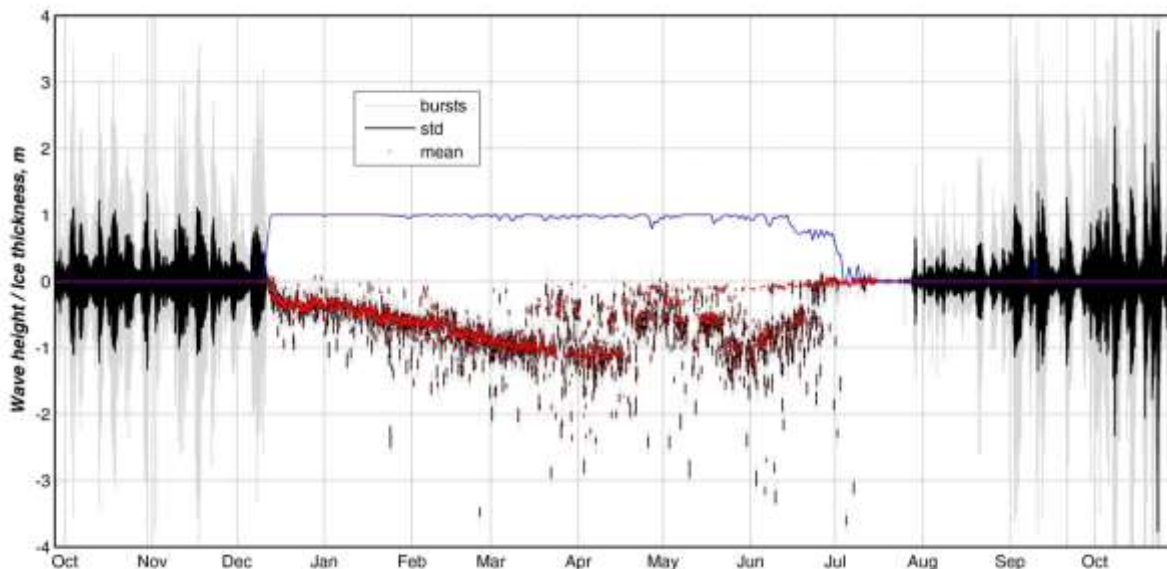
Figure 13. The sea-level heights and ice thicknesses recorded by upward-looking Nortek ADCP at AN01 mooring. Blue line shows AMSR2 sea ice concentration in the mooring position.

Another piece of important information has been received from the combination of two upward-looking ADCPs : WorkHorse 300 kHz by RDI deployed near the sea floor and Signature 500 kHz by Nortek at AN01 and NE03. Both instruments provided the continual records of water dynamic in entire water column with 15 min recording interval. Moreover, Signature 500 was equipped with 5th vertical beam that allowed measuring the wave heights and directions as well as the draft of ice throughout the full seasonal cycle (Figure 13).

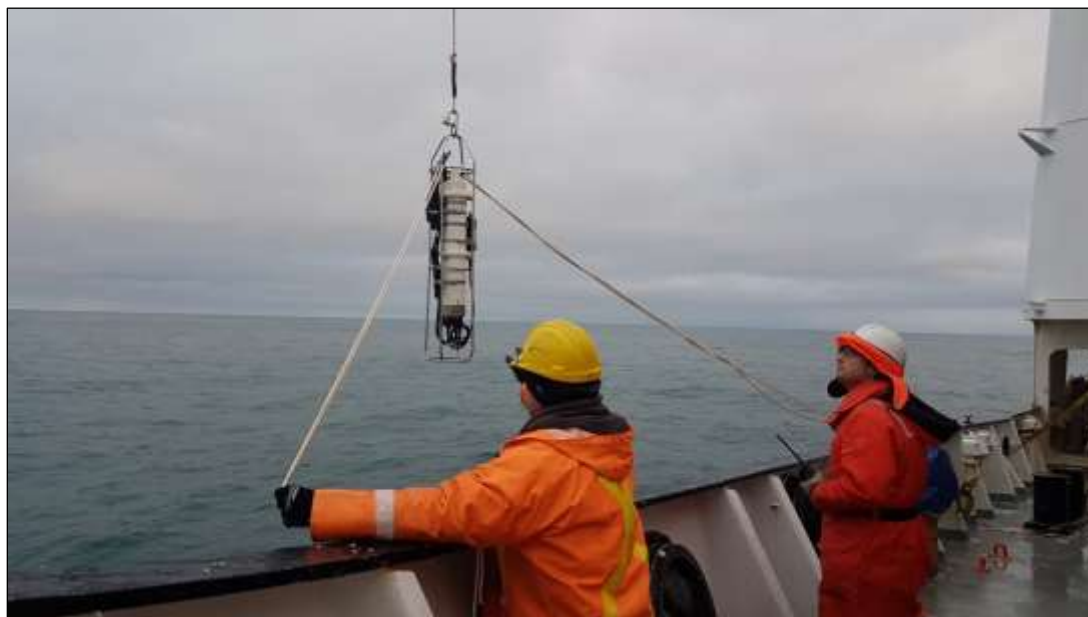
Figure 14. CTD cast from the foredeck

For the hydrological measurements, we used SBE 19plusV2 CTD profiler with a set of various sensors (see Table 1) mounted on a frame. CTD casts were made from the starboard side of foredeck with an assistance of ship's crane and winch (Figure 14). The depth of each cast was limited by ~ 10 m above the sea floor from the safety considerations, although the maximum distance to the bottom at each station could be higher taking into account the tilt of the rope because of current and ship's drift. Totally, 4 CTD casts were made at the mooring positions and one cast was made in between NE02 and NE01 positions (Table 2).

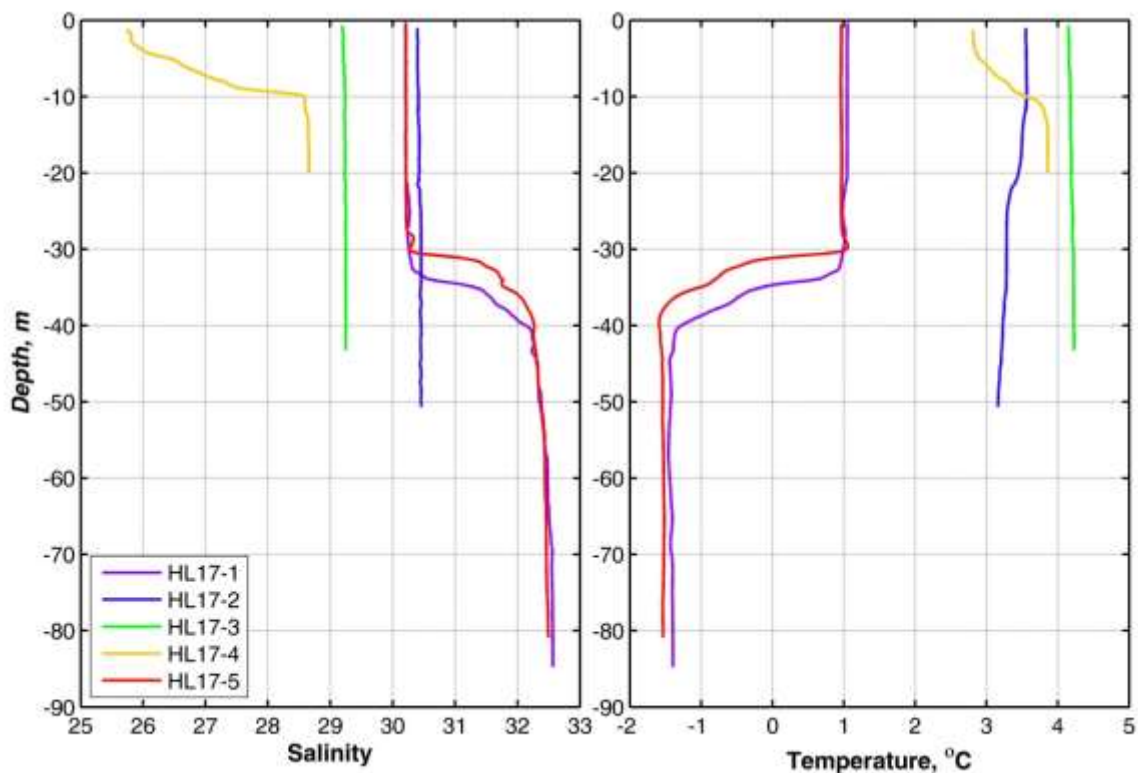
Figure 15. Temperature and salinity profiles collected during the cruise

Temperature and salinity profiles were recorded at the mooring locations either before the mooring recovery (AN01, NE03, and NE02) and after re-deployment (AN01). The vertical CTD profiles collected at AN01 position show the freshened (~ 2 psu) surface layer with a pycnocline located at 30-35 m (Figure 15). The fresher surface waters there seem to be mostly associated with a local melt of sea ice in summer. The melt of 1.5m ice with a salinity of 4 would result in diluting of surface 30 m layer by 1.4 that is reasonably close to the observed salinity anomalies. In the Nelson area, the only station showing the presence of vertical stratification is HL17-04, where the salinity at surface ~ 3 psu lower compared to the bottom layer. The vertical stratification at the stations located further off-shore is absent. This fact is likely attributed to the intensive wind-driven vertical mixing initiated by several sequential strong storms in mid-October with an average wind speed exceeding 20 m/s. The thermal stratification matches, in general, the salinity profiles. The surface waters were well above freezing point and ranged from 1° C in AN01 position to $3-4^{\circ}$ C north-east of Nelson mouth (Figure 15).
